Chapter 19

Riverbed mining as a threat to in-stream agricultural floodplain and biodiversity of Ganges River, India

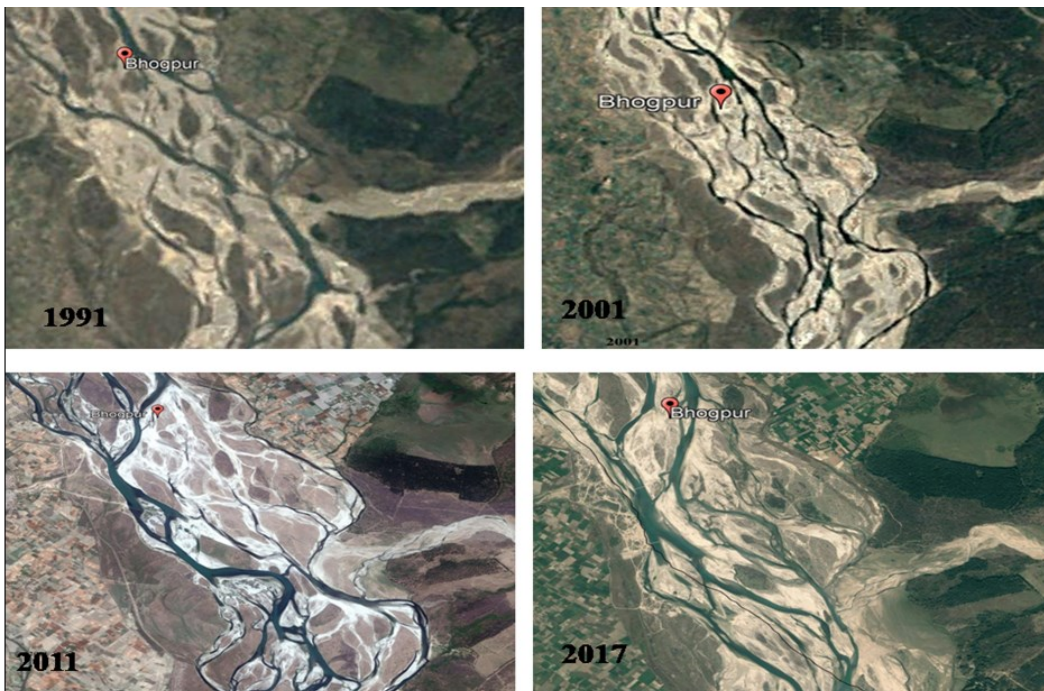
Figure 19.2. Changing pattern of channel morphology of River Ganga in Bhogpur Village during 1991, 2001, 2011 and 2017.

The change in flow energy of water and sediments has evolved the river channel in different bed forms. The flow of the river built up and maintains the river channel by deposition of sediments and erosion of nearby area (Whiting, 1998; Heede, 1986; Padmalal and Maya, 2014). Riverbed mining is one of the most devastating anthropogenic activities which affects and obstructs the natural riverbed forms. Extraction of riverbed materials targets the morphology of river and disturbs the balance of river channels by interception of the material load. The changes in channel pattern are due to the reduced supply of bed load sediments. Due to the riverbed mining activity, the main channel got divided into the various small stream orders which led to the different riverbed forms. The changes in the channel morphology of River Ganga near Bhogpur village are shown in Figure 19.2 through satellite images of 1991, 2001, 2011, and 2017. Figure 19.3 shows the drainage map of River Ganga during 1991, 2001, 2011, 2017 and demonstrates the large measurable changes in channel pattern of River Ganga over two decades.

In the past two decades, both manual and mechanical mining has changed the channel pattern in way of channel instability, changes in channel width, division of the main channel in various small stream orders and bank erosion. In the upstream mining, the head cutting of channel increase the slope of the river. Gravel bar skimming found out during the study period and it creates the instability of channel and changes the width of the river. Kondolf (1997); Kondolf and Swanson (1993) show the change in channel pattern due to the dams and gravel mining. Rinaldi (2005); Padmalal and Maya (2014); Kamboj *et al.* (2017) also described the effect of sand mining on channel morphology like changes in width, an increase of slope due to the upstream mining, instability of channel due to the downstream mining, changes in cross-sectional area of the river.

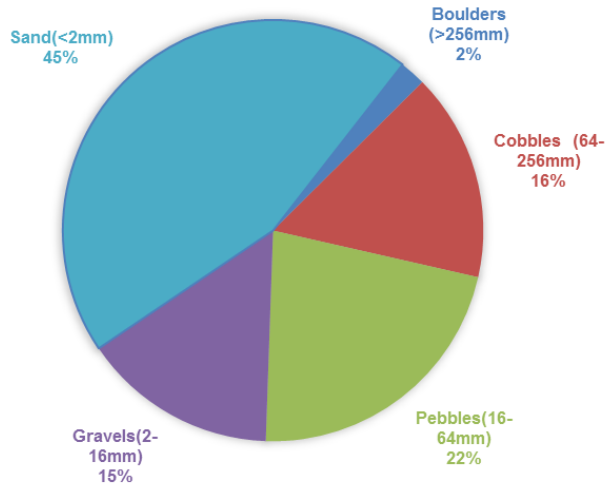
Figure 19.4. Physiographical parameters of river Ganga at Bhogpur village.

The physiographical parameters are an important part of the river bed; it is the mixture of boulder, stone, gravel, cobbles, sand, silt and clay. The physiographical parameters of River Ganga are shown in Table 19.1. During the study period, the bottom substrate covered with 2% boulders, 16% cobbles, 22% pebbles, 15% gravel and 45% sand. The physiographical parameters important for the aquatic organisms for their reproduction process, and habitat of many aquatic organisms like benthos, fishes (Figure 19.4).

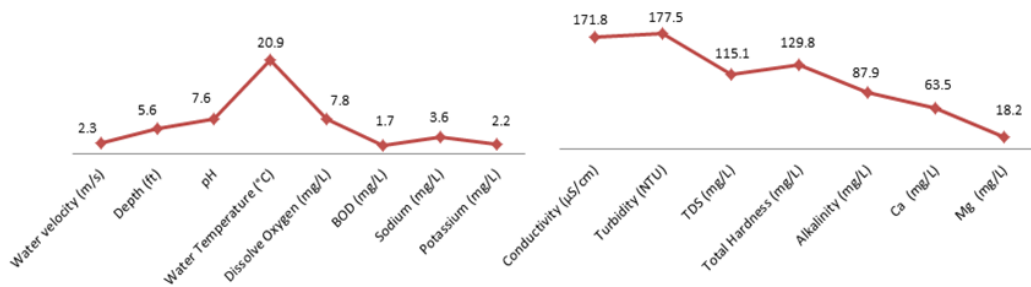
**Figure 19.5.** Water quality of River Ganga at Bhogpur Village.

The physico-chemical parameters provide a fair idea of water quality of a water body. A total of 15 water quality parameters were selected to know the quality of River Ganga in a stretch of Bhogpur village shown in Table 19.2. Mean of water velocity 2.3 ± 1.9 m/s, average depth of river 5.6 ± 1.4 ft, average water temperature of river water $20.9 \pm 4.6^\circ\text{C}$, mean pH value of river water 7.6 ± 0.6 ; conductivity value 171.8 ± 44.7 $\mu\text{S/cm}$; TDS value of river water 115.1 ± 29.9 mg/L; turbidity value of river water 177.5 ± 204.1 NTU; dissolved oxygen of river water 7.8 ± 0.5 mg/L; biochemical oxygen demand (BOD) of river water 1.7 ± 0.6 mg/L; alkalinity of river water 87.9 ± 11.6 mg/L as CaCO_3 ; total hardness of river water 129.8 ± 16.6 mg/L, average value of calcium and magnesium 63.5 ± 9.1 mg/L and 18.2 ± 2.15 mg/L respectively, average value of sodium and potassium 3.6 ± 0.7 mg/L and 2.2 ± 0.4 mg/L respectively were recorded during the study period. All the parameters were within the permissible limit given by BIS standards 2012, except turbidity. During the study period, turbidity was higher because of the mining activity but the turbidity of water persists temporarily because of the high velocity of water (Figure 19.5).

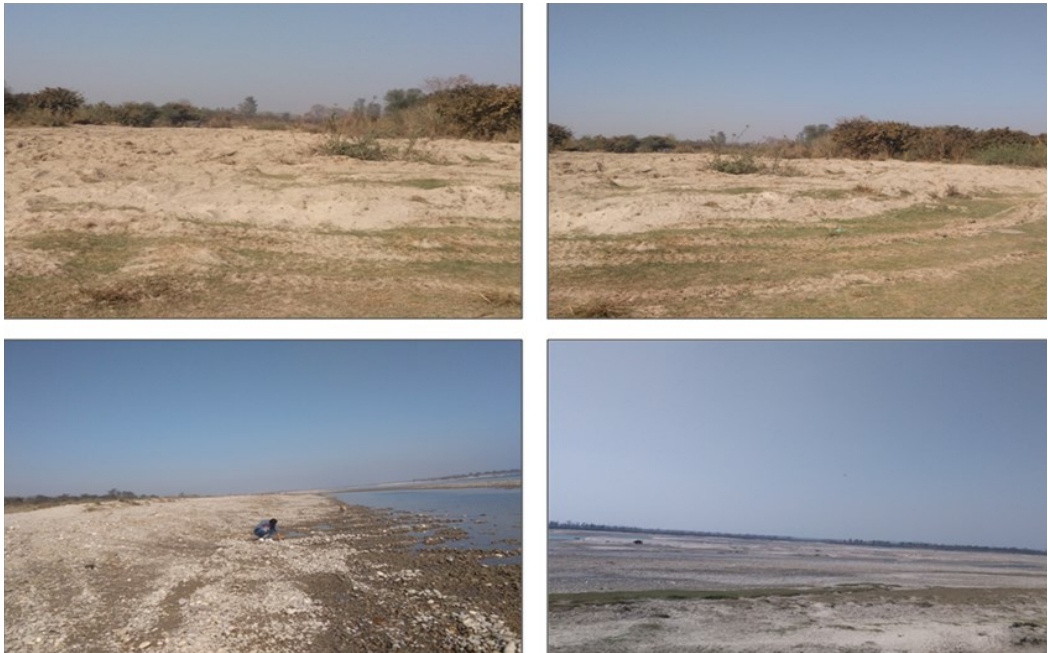
Figure 19.7. Riparian vegetation disturbed due to the transportation of Riverbed material.

The riparian vegetation is a link between aquatic and terrestrial ecosystem of a river. The riparian vegetation pertains to the vegetation which is found on the banks of any river. A good riparian zone was recorded on both the banks of river Ganga. The vegetation was recorded in the form of many types of shrubs and herbs shown in Table 19.4. The main factors for degradation of the riparian vegetation were the transport process of the raw material and illegal mining near the bank of the river shown in Figure 19.7.

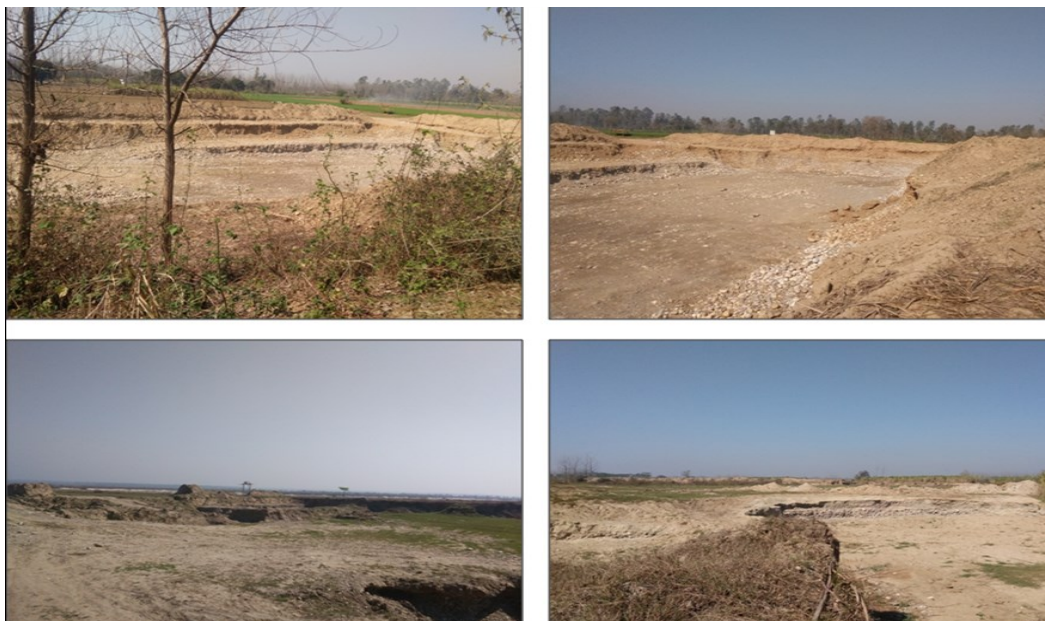
Figure 19.8. Unscientific mining in the agricultural fields at Bhogpur village.

Bhogpur village has a good agriculture field. The common agricultural crops are wheat, rice, popular, sugar cane. But due to the high demand of the raw materials, the agriculture area was destroyed by the illegal mining. They removed the upper layer of the agricultural field by using mechanical sources like JCB, after the removal of the fertile soil layer; they extract the stone, boulder from the lowest layer of the agricultural field shown in Figure 19.8.
